Report on the investigation of
injury to a passenger on board the RIB

Celtic Pioneer

26 August 2008

Report No 11/2009
May 2009

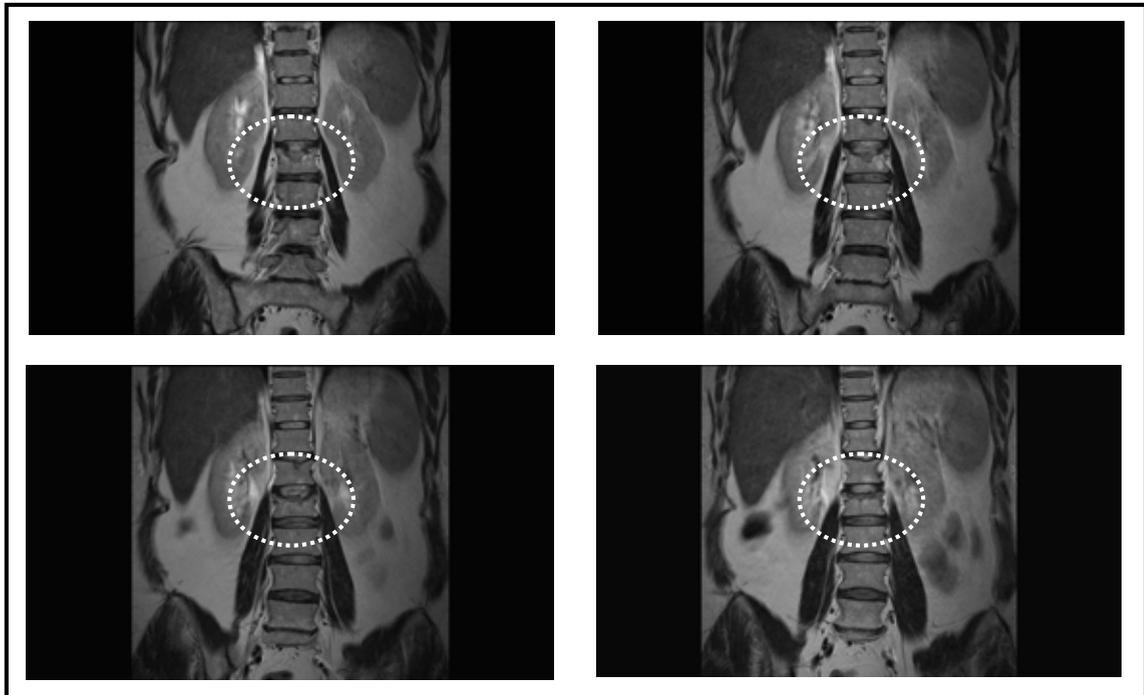
The injured passenger suffered '*a compression fracture of the second lumbar vertebra (L2) with compression of the superior (upper) end plate*' (**Figure 5**). The moderately high energy fracture resulted in the separation of a fragment of vertebral body which had the potential to cause neurological damage (**Annex E**).

Scans of injury suffered

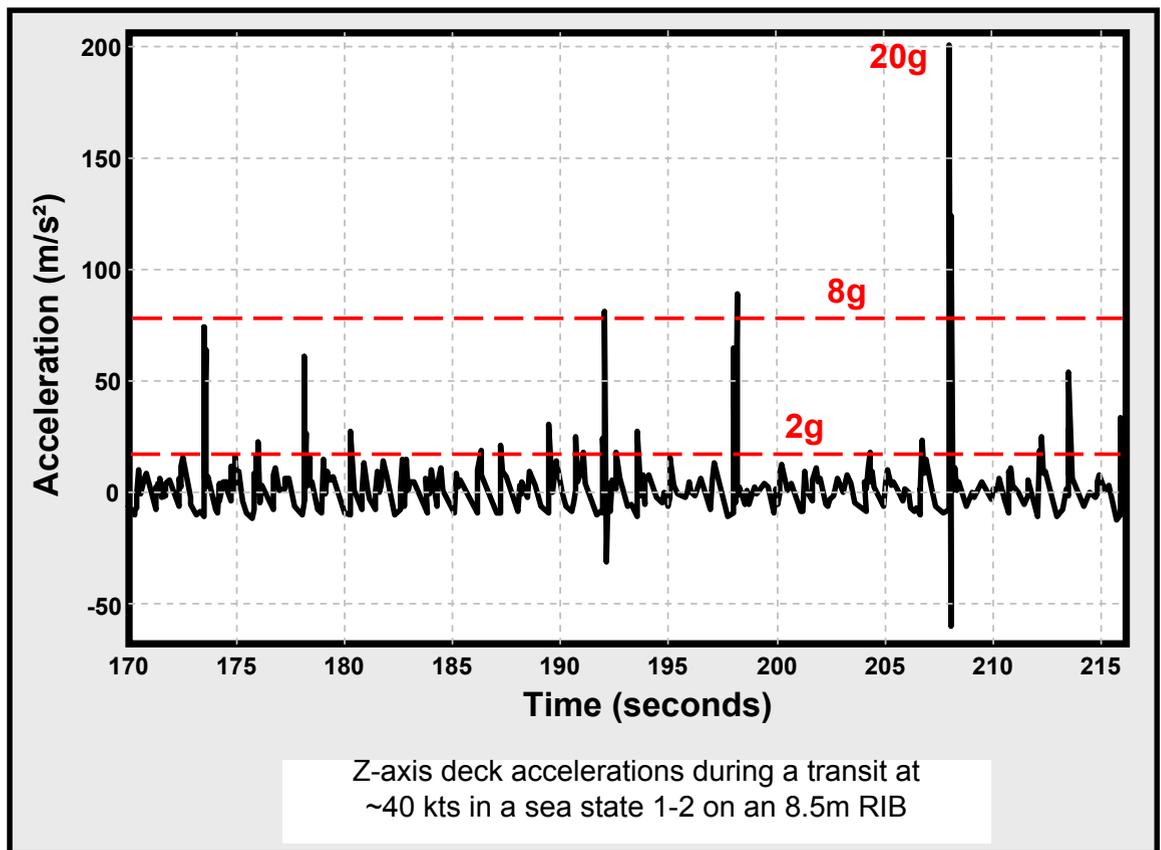
Figure 7

Not only did the trials demonstrate that the repeated shocks expected during high speed operations can occasionally be of sufficient magnitude to cause impact injuries, but they also clearly justify the requirement for fast boat operators to conduct a shock and WBV risk assessment and take the appropriate steps listed in the Vibration Regulations to reduce the risk of chronic and acute injuries to employees to as low as reasonably practicable. A person exposed to the shock and vibration levels shown in **Figure 7** exceeds the 8 hour WBV EAV within 15 minutes. **Figure 8** illustrates that after 1 hour, the level of exposure is up to 7.5 times the EAV and 3 times the ELV allowed maxima.

Magnitude and frequency measurements for shock recorded on board an 8.5m RIB

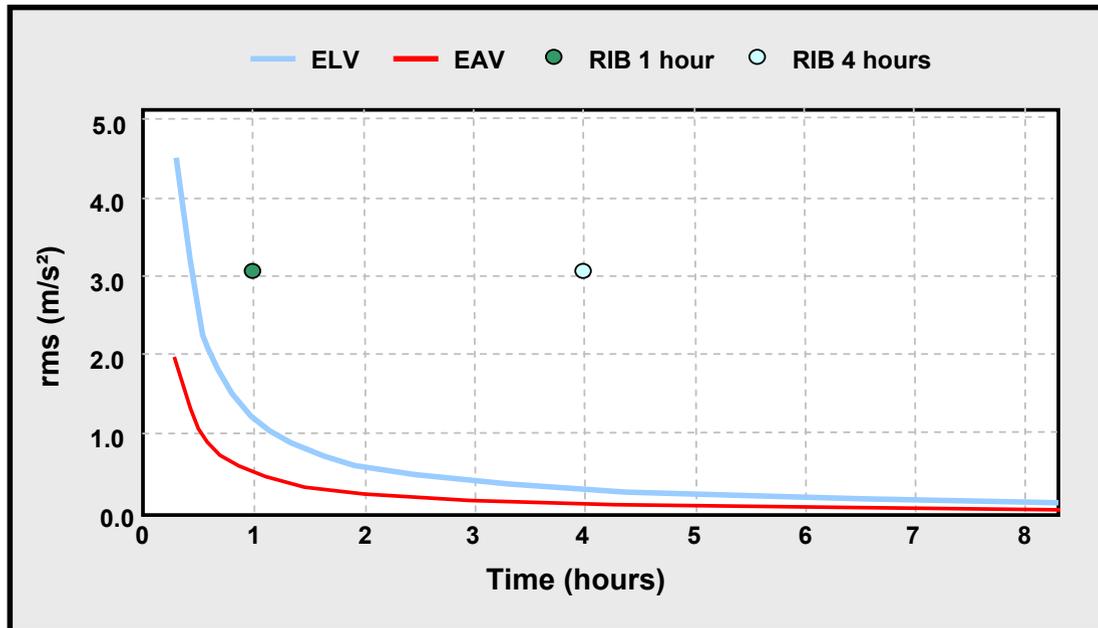
Figure 8

An example of how a RIB travelling at ~40 kts in a sea state 2 will exceed the EU WBV Exposure Action and Limit Values

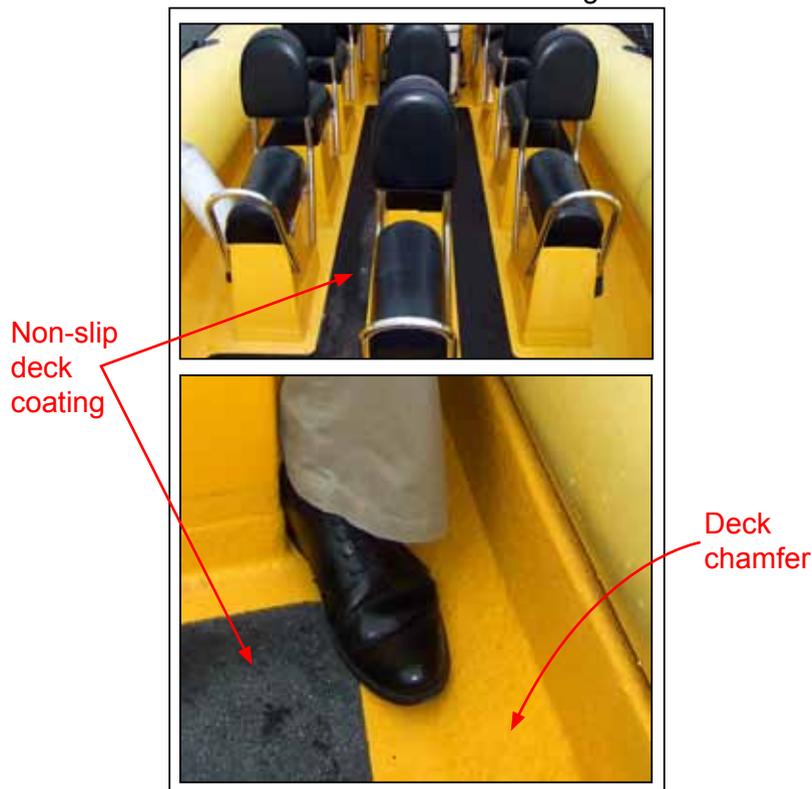
Figure 9

Careful consideration of human factors engineering issues during the design stage for high speed craft can significantly reduce the levels and effect of shock and vibration. Bay Island Voyages had invested in new, well built RIBs from an established manufacturer, which were designed specifically for this type of activity. However, a number of design features have been identified that adversely affected the casualty's ability to sustain the required posture and therefore increased the likelihood of her suffering a spinal compression fracture.

Celtic Pioneer deck design factors

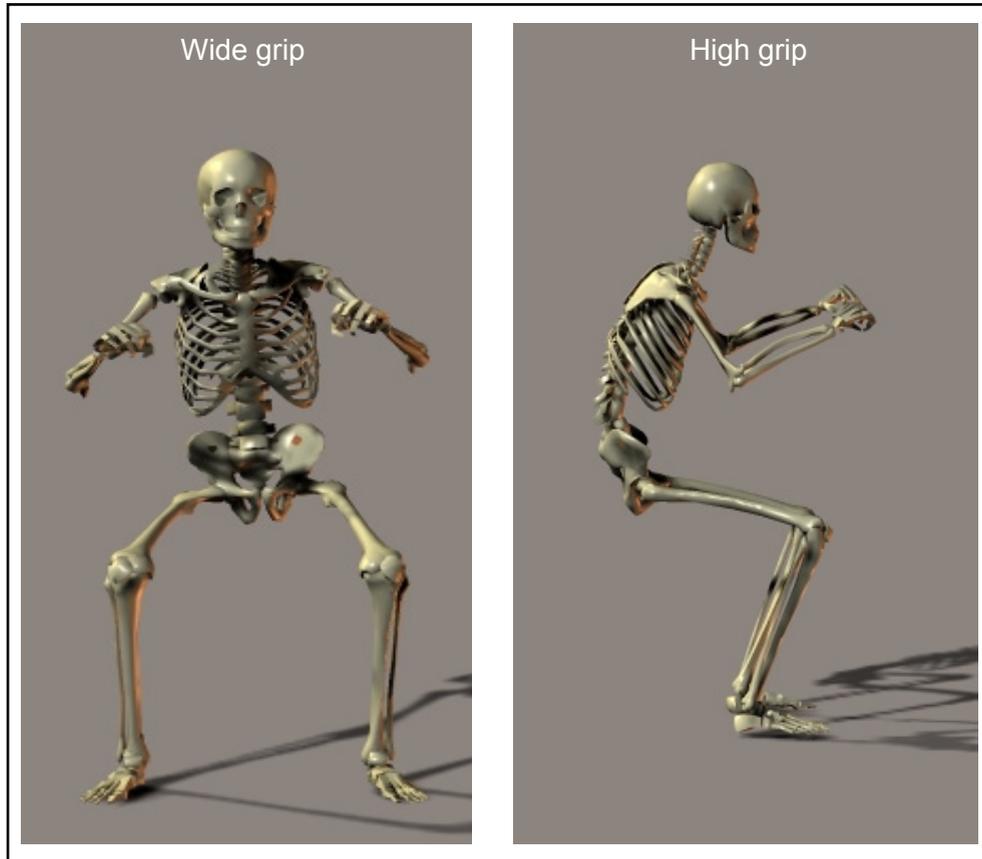
Handrails or handgrips, particularly when affording a high and wide grip, allow passengers to support themselves against impacts during high speed manoeuvring or while dodging waves (**Figure 11**). The position of the handrail on the front row of seats on board *Celtic Pioneer* was lower than those provided on the seats behind. The reduced height of this rail would have made it difficult for the injured passenger to stop herself being thrown forward on impact with the sea. It would also have caused her to assume a more stooped posture while underway (**Figure 12**). Furthermore, the relatively narrow handrail is likely to have offered the injured passenger limited lateral support against impacts with the water during a turn. The handrails on the front row of seats were also open to the elements, exposing the hands of the occupants to the effects of wind chill and sea spray. It was probably a combination of these factors which contributed to the injured passenger's decision to hold onto the buoyancy tube rope with her left hand. Bay Island Voyages' advertising leaflet (**Annex A**) shows a passenger, occupying the corresponding seat on board *Celtic Ranger*, taking similar action. The resulting posture is likely to have introduced a degree of bending and twisting to the casualty's lower back as *Celtic Pioneer* dodged the waves. This would have significantly increased the risk of her suffering a wedge compression fracture (**Figure 13**).

The effects of handgrip or handrail design on passenger posture and stability

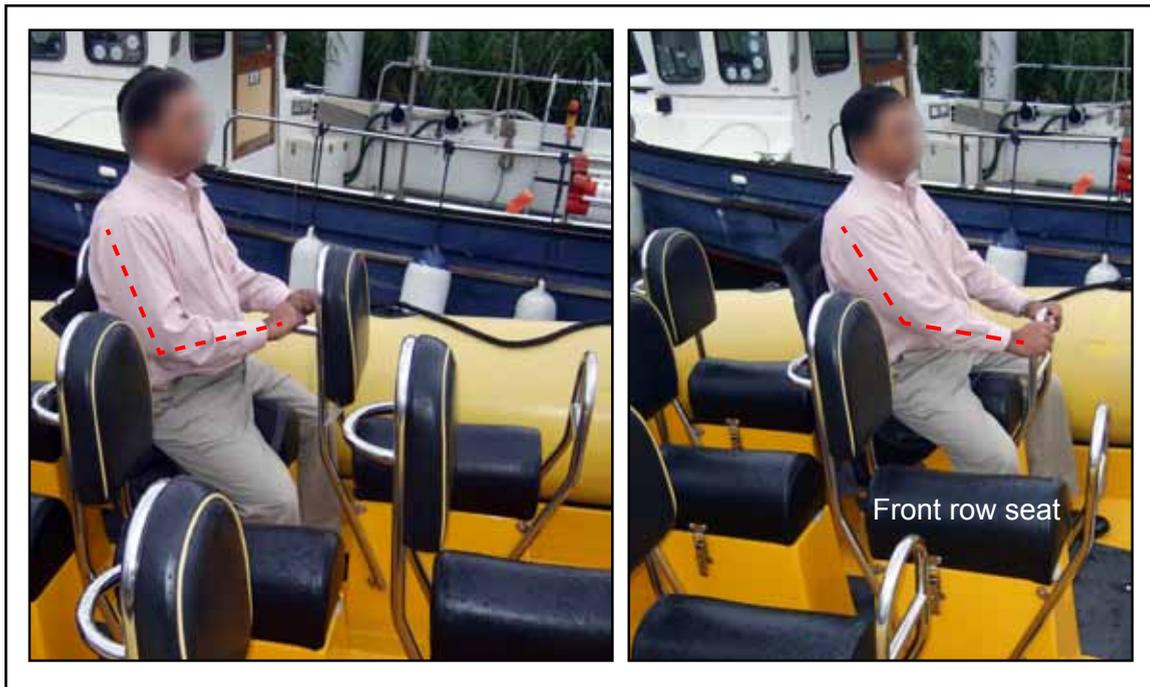
Posture factors associated with the casualty's seat

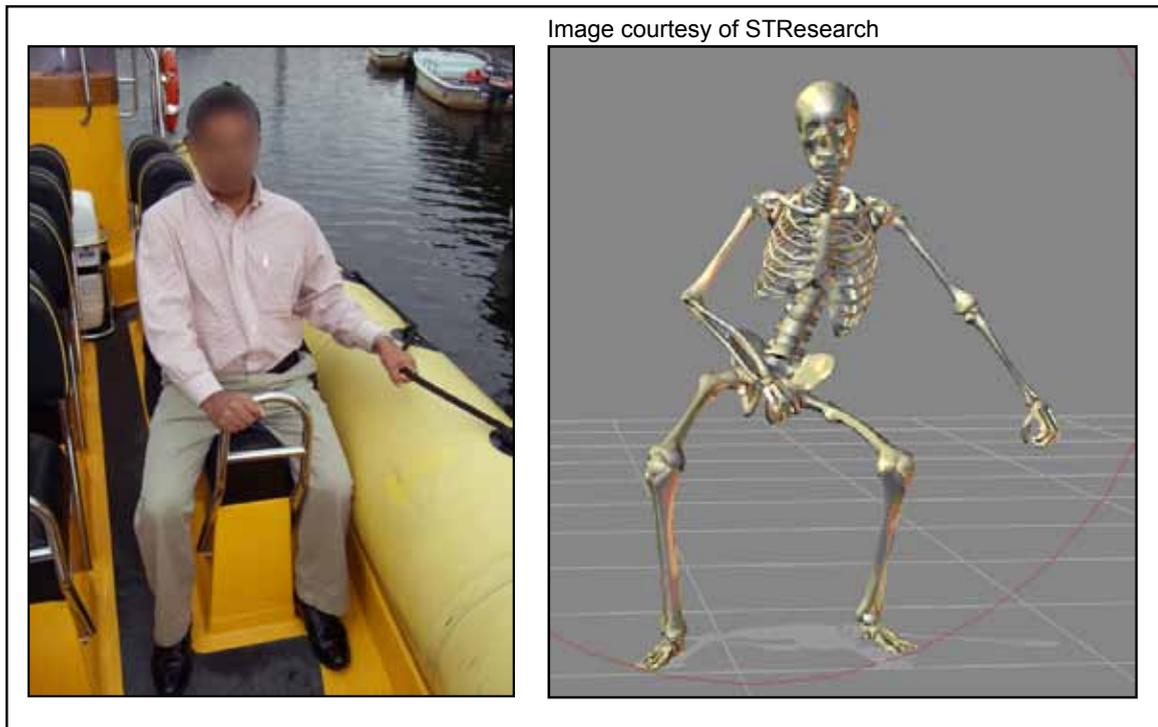
The type of injury suffered typically occurs in the lumbar spine as a result of an axial load⁵ being applied with a degree of forward flexion, and is commonly referred to as a 'wedge' compression fracture. Spinal wedge compression fractures are common among people who have fallen from a height, been involved in a head on car crash, experienced a violent helicopter landing or have ejected from a military aeroplane. The constant pitching and rolling of a boat in a seaway destabilises the upper body, and the resulting shocks due to wave slamming allow this mechanism of injury to be easily mimicked during fast boat rides. Shocks and vibrations resulting from the impacts between a boat's hull and the sea are transmitted through its deck and seats to the passengers and crew. The size of the shocks experienced by people on board a boat are significantly magnified when their bottoms leave the seats and then land as the boat rises up towards them.

Illustration of the probable spinal alignment of the casualty at the time of the accident
