Report on the investigation of
injury to a passenger on board the RIB

Celtic Pioneer

26 August 2008

Report No 11/2009
May 2009

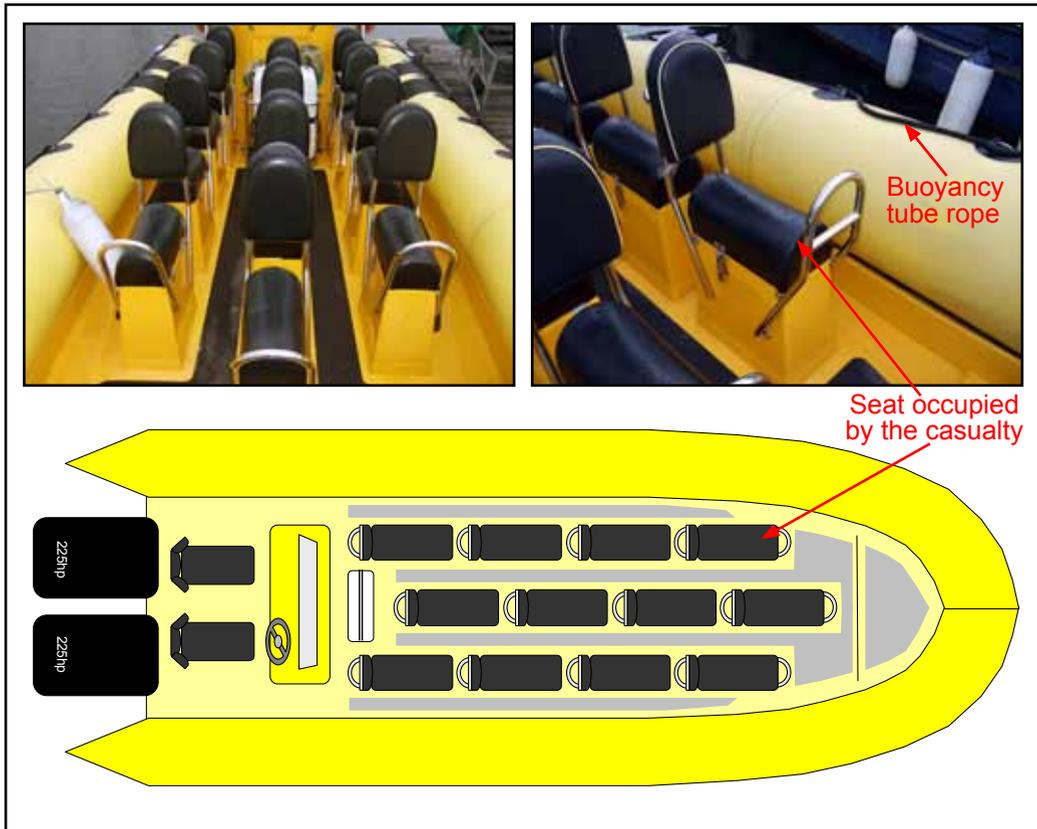
Figure 2

After between 5 and 10 minutes the hands of the female passenger seated in the front row on the port side of the boat became wet and cold. Consequently, she found it difficult to maintain her grip and posture and had to steady herself by holding onto the rope attached to the buoyancy tube (**Figure 2**) with her left hand. The owner sensed that she was uncomfortable and instructed the skipper to stop. He then asked the passengers if they were okay and offered them the opportunity to change seats. The majority of passengers responded positively, and one opted to move from his seat at the rear of the boat to the vacant one positioned furthest forward. Several of the passengers did not feel comfortable but did not voice their concerns. The skipper and owner then assessed that everyone was okay, and continued with the trip.

Celtic Pioneer seating positions

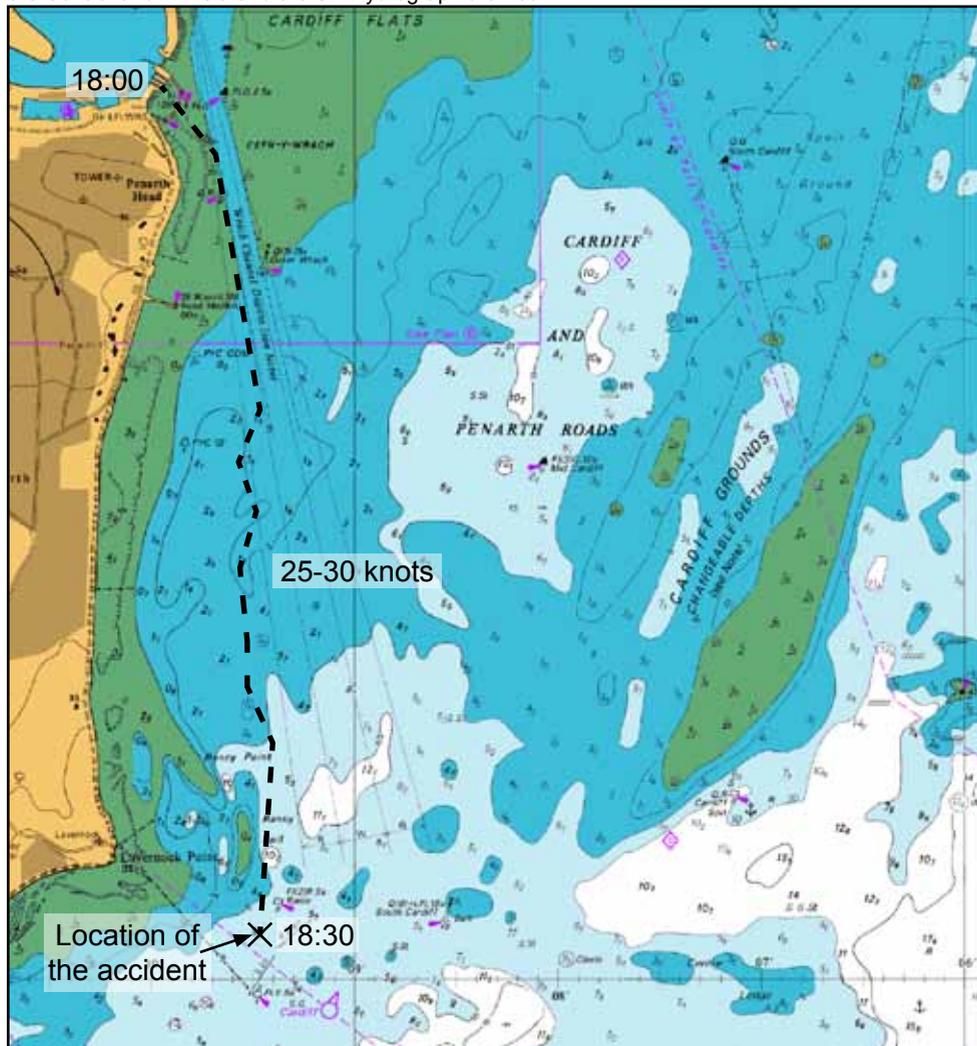
Figure 4

Extract of chart BA 1182 - passage and accident location

As *Celtic Pioneer* approached the Rannie buoy the seas became choppy. The skipper slowed to approximately 10 to 12 knots and began to dodge between and over the waves. At approximately 1830, the motion of the boat lifted the female passenger in the front row into the air. She then landed heavily on her seat and screamed due to a sudden intense pain in her lower back. The skipper immediately stopped the boat. The injured passenger moved from her seat towards the bow and lay down. Two passengers, one of whom was a consultant doctor, immediately went to her assistance, quickly followed by the boat's owner. The owner instructed the skipper to turn around and head slowly back towards Cardiff Bay. The casualty was in extreme pain and was wet and cold. She was positioned on her back with her head resting on a fender and her feet elevated onto the RIB's buoyancy tube. The owner used two of the boat's thermal protective aids as blankets to shelter her from the elements.

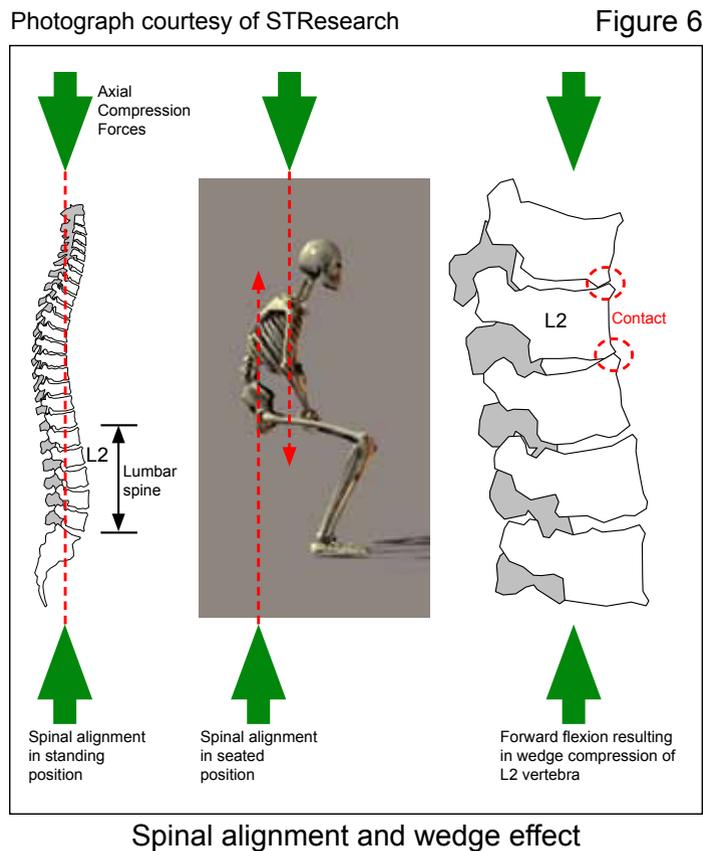
loading. It is the combination of the flexion of the spine and the axial forces applied that causes contact between the vertebrae and results in fractures due to the wedging effect (**Figure 6**). If a twist or bend is introduced to the lower back region the risk of this type of injury is further increased. Research indicates that the introduction of a twist can reduce the mechanical strength of the vertebra/intervertebral disc unit by about one third.

People suffering from osteoporosis, which causes a loss of mineralization and results in a reduction of BMD, are more prone to spinal wedge compression, and other types of fracture. Groups at an increased risk of developing this condition include: the elderly, post menopausal women and women with a strong family history of osteoporosis.

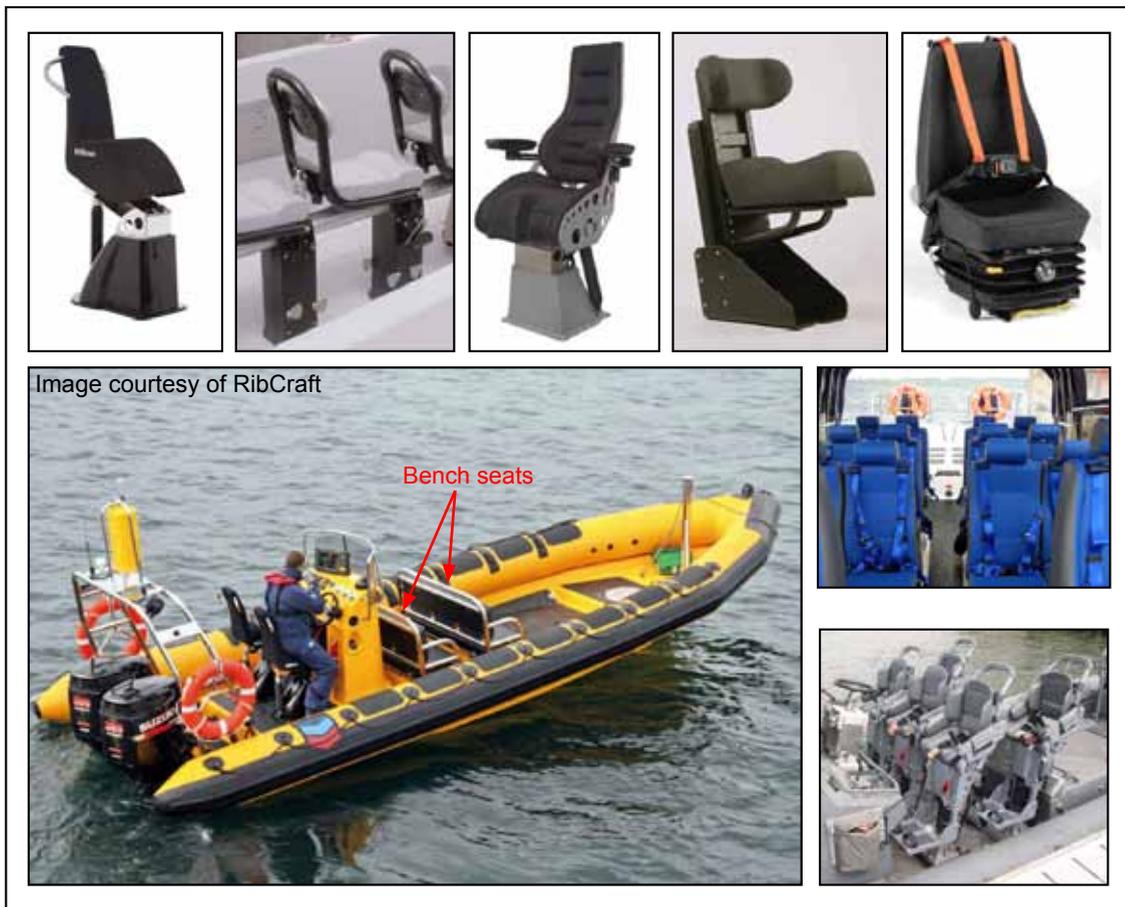
Figure 10

Seats are available for use on high speed craft, which are designed to dampen the transmission of shock and vibration and improve the occupant's posture and spinal alignment. Some of the most commonly adopted designs include shock absorption systems, restraint harnesses, and adjustable features to allow for people of differing sizes (**Figure 10**).

Examples of seats used on board high speed craft

Shock absorption is not simply a case of adding extra padding to a seat. Although this might increase the comfort of its occupant when the boat is at rest, it will not necessarily provide a reduction in the magnitude of vibrations felt while underway. Indeed, the use of certain cushioning materials can lead to an increase in shock and vibration magnitude (**Annex F**). However, there are several suspension seats available which significantly dampen out the magnitude of repeated shocks and reduce exposure to WBV. Restraint harnesses help ensure an occupant stays in contact with the seat while underway, and offer additional support and a sense of security as the boat is manoeuvred at speed or in choppy seas, but they present other hazards that need to be carefully considered. Adjustable seats will help passengers of varying sizes assume the designed optimum posture.
